Pest Inspection Report

(Complies with AS 4349.3-2010)

9 Tango Close
Jordan Springs NSW 2747

| Date: 18/09/2016 | Time: 09:30 AM | Report ID: 160918 AllyZhou P |

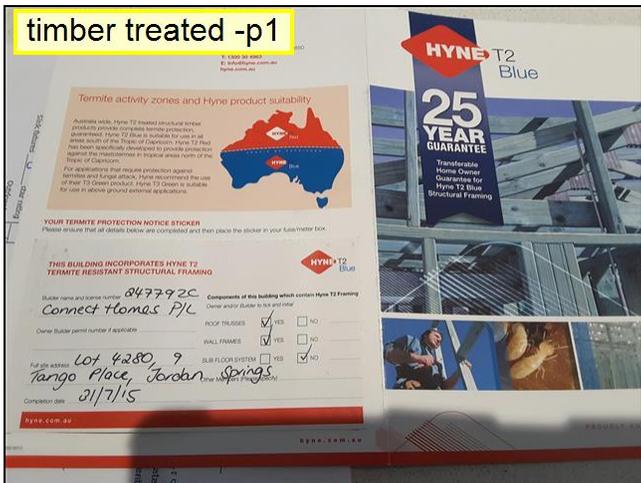
1.3 Item 1(Picture)

- 1.0 No active evidence of termites has been found at the time of inspection. Read the report in its entirety.
- 1.3
 1. Roof and wall frame have been treated to protect termites
 2. Termites physical barrier have been done before the house is built
