# Building Inspection Report

**Ms. Ally (Yanxia) Zhou**

**Property Address:**

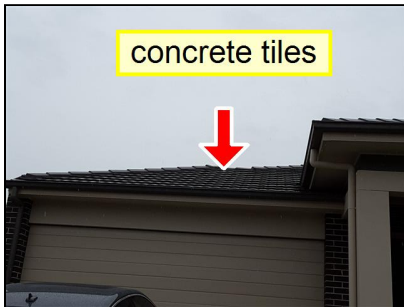
2.0 Item 1(Picture)

**2.0** The main section of the residence has a concrete tile roof supported by a treated pine truss frame and having foil sarking and fibreglass insulation (see sec 6.1) within the ceiling space. The roof shows no significant signs of deflection which would appear to indicate that the trusses are suitable for the purpose of the supporting the weight of this tile roof.

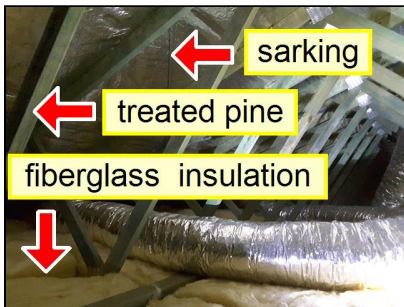
6.1 Item 1(Picture)

**6.1** Moisture fine in the timbers of loft and the roof frame is treated pine ( read sec 2.0)
